THE SPACE SHUTTLE *CHALLENGER* AND *COLUMBIA* ACCIDENTS**The NASA Space Shuttle Disasters**

The Space Shuttle *Challenger* Disaster

The Space Shuttle *Columbia* Failure

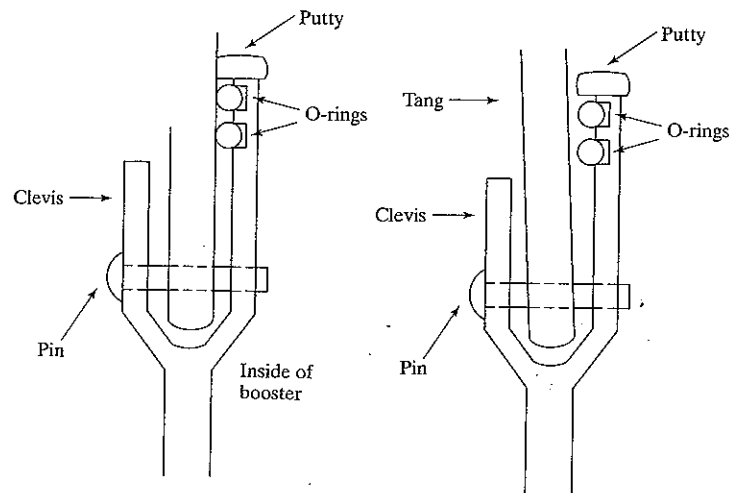
Figure 1.1

Problems with the field-joint design had been recognized long before the launch of the *Challenger*. When the rocket is ignited, the internal pressure causes the booster wall to expand outward, putting pressure on the field joint. This pressure causes the joint to open slightly, a process called "joint rotation," illustrated in Figure 1.1b. The joint was designed so that the internal pressure pushes on the putty, displacing the primary O-ring into this gap, helping to seal it. During testing of the boosters in 1977, Thiokol became aware that this joint-rotation problem was more severe than on the Titan and discussed it with NASA. Design changes were made, including an increase in the thickness of the O-ring, to try to control this problem.

(a) A schematic drawing of a tang and clevis joint like the one on the *Challenger* solid rocket boosters.

(b) The same joint as in Figure 1.1a, but with the effects of joint rotation exaggerated. Note that the O-rings no longer seal the joint.
